Debris/Ice/TPS Assessment and Integrated Photographic Analysis of Shuttle Mission STS-88

**DEBRIS/ICE/TPS ASSESSMENT
AND
INTEGRATED PHOTOGRAPHIC ANALYSIS
OF
SHUTTLE MISSION STS-88**

4 December 1998

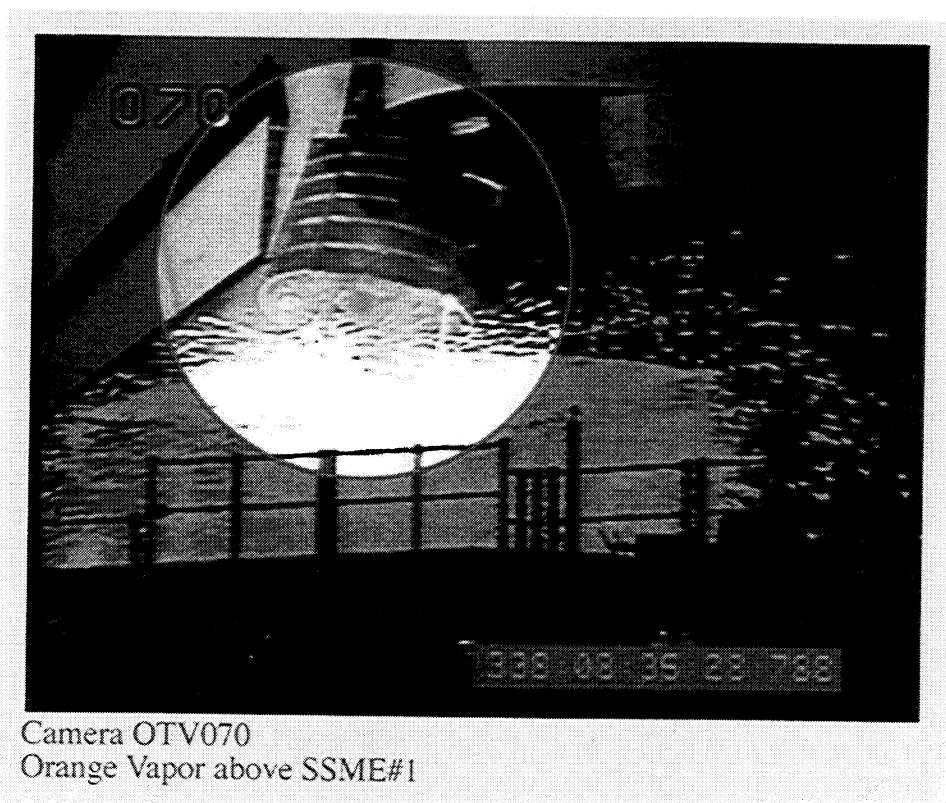
Figure 2.3.1 (B) Orange Vapor forward of SSME # 1 Rim

Orange vapor was visible drifting forward from the aft end of the vehicle near the SSME rims toward the base of the vertical stabilizer during SSME ignition. Orange vapor has been observed on previous missions. (Cameras E2, E17, E18, E20, E36, OTV063, OTV070, OTV071, KTV21A)

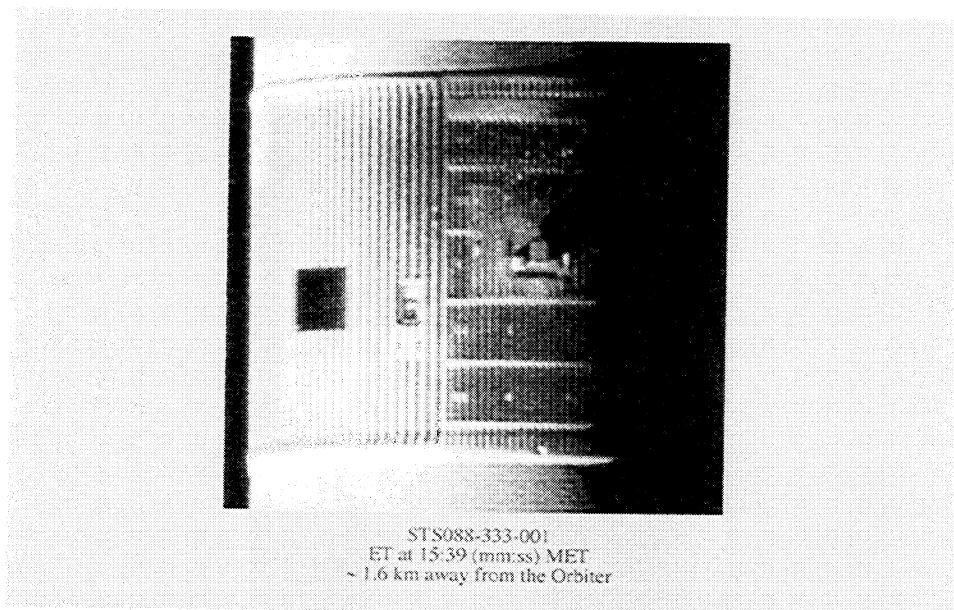
Figure 2.5.4 (A) -Z Intertank and -Y Thrust Panel of the ET at ~1.6 km

Figure 2.5.4 (A) is a view of the -Y thrust panel taken at ~1.6 km distance from the Orbiter. The minimum resolvable object size is ~ 3 inches. The -Y thrust panel TPS does not appear significantly damaged at this level of detail. However, an ~ 9 inch divot is visible at the junction of the -Y thrust panel and the LH2 tank-to-intertank close-out flange.

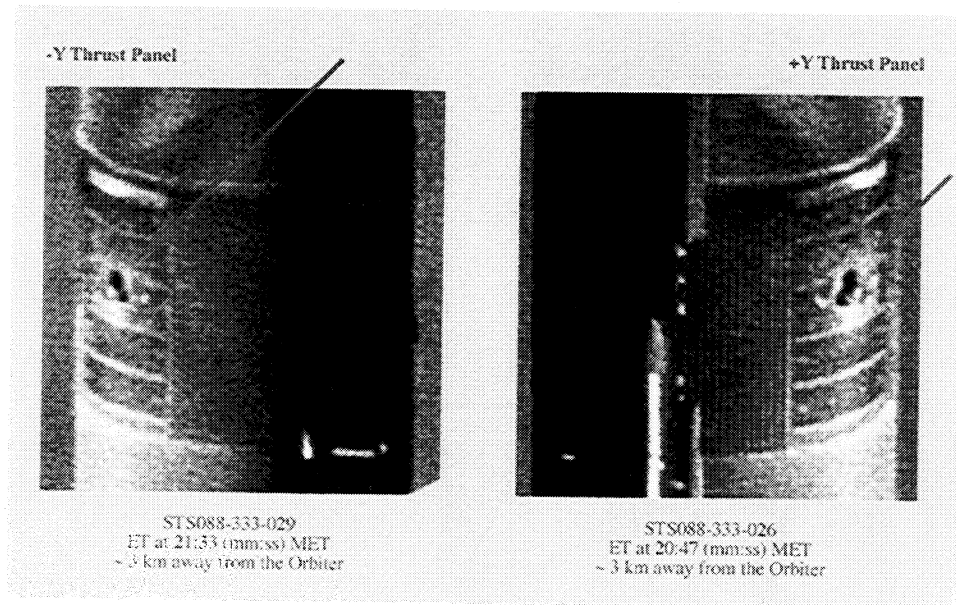
Figure 2.5.4 (B) -Y and +Y Thrust Panels of the ET at ~ 3.0 km

The STS-88 -Y ET thrust panel appears relatively clean on the digitally enhanced and the original negative photography while the +Y thrust panel has somewhat variable appearing tones / textures near the forward attach strut.

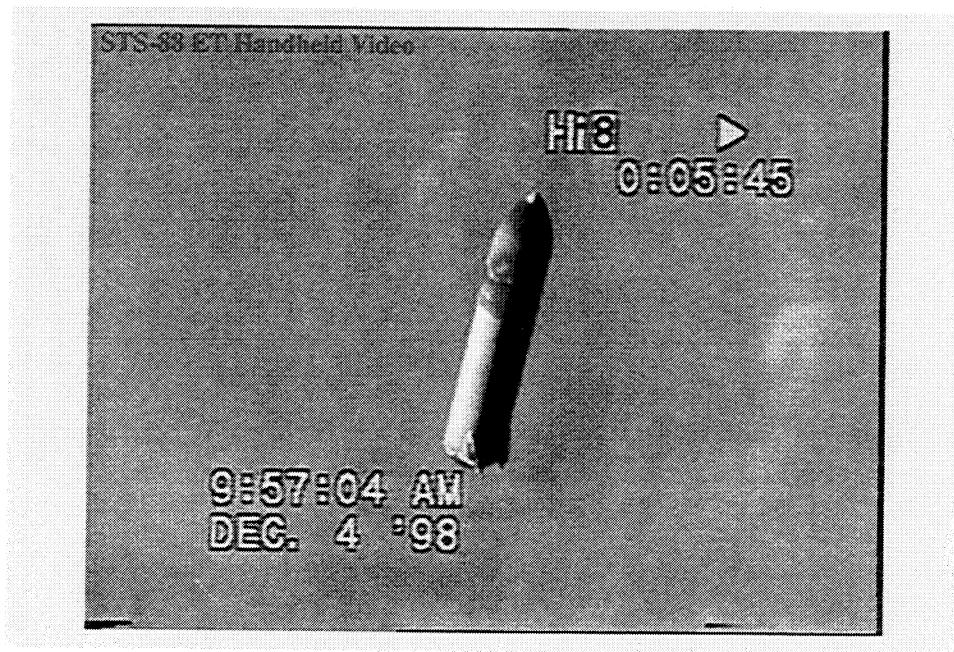
Figure 2.5.5 Handheld Video View of the ET

Approximately fifteen minutes of video of the ET was obtained on STS-88. Timing data was present on the on-board tapes which was read from the Cannon L2 camcorder post-flight. No ET venting was detected on the STS-88 imagery (venting was seen on the five previous missions).
